ASTURIA COMMUNITY DEVELOPMENT DISTRICT FULL RESERVE STUDY REPORT

For 30-Year Projection Period: FY 2023 through FY 2053

Odessa, FL

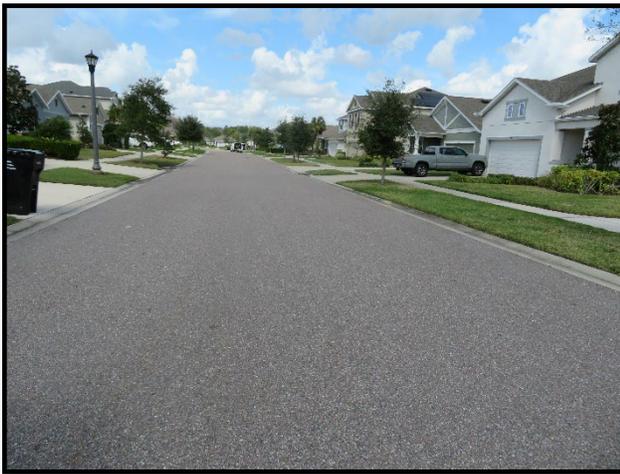
The District maintains approximately 105,350 square yards of asphalt pavement streets throughout the community, including the clubhouse parking area. The pavement is in good overall condition and dates from 2016 to 2020. Asphalt pavement comprises multiple layers. Typically the top layer, or surface course (comprised of a wearing course atop a binder course) deteriorates over time and can be milled, or removed, and overlaid, or replaced. The following diagram depicts typical pavement layers.

Asphalt pavement at Renaissance Avenue

The useful life of the asphalt pavement surface course is from 15- to 25-years. We recommend the District budget for phased milling and overlayment of the pavement beginning by 2041 and concluding by 2045. The District should retain an engineer for quality control.

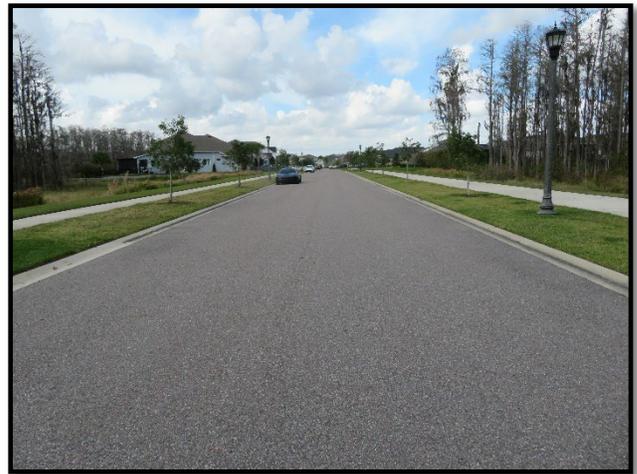
Asphalt pavement at Aviles Parkway

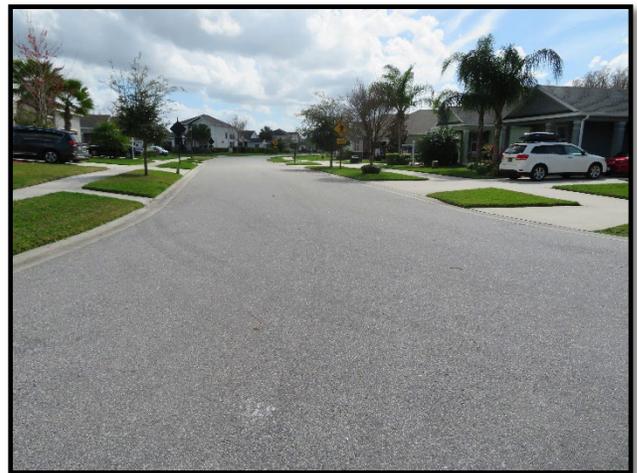
Asphalt pavement at Trails Edge Boulevard

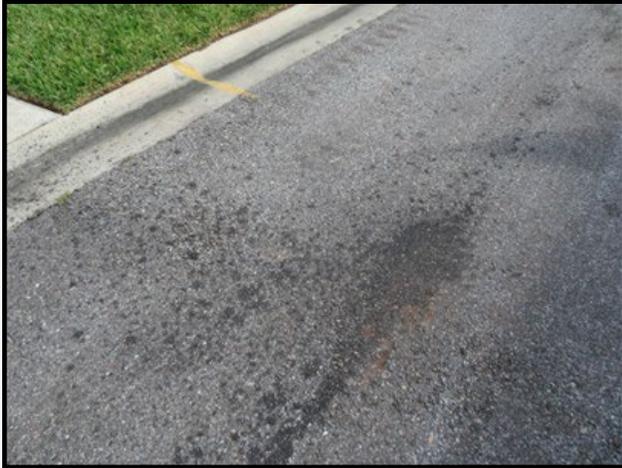
Vehicular fluid stains at alley adjacent to Claymore Street

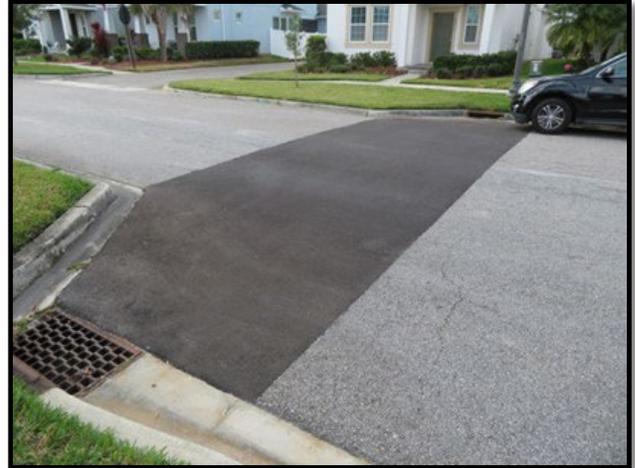
Pavement repair due to subsurface pipe repair at Claymore Street

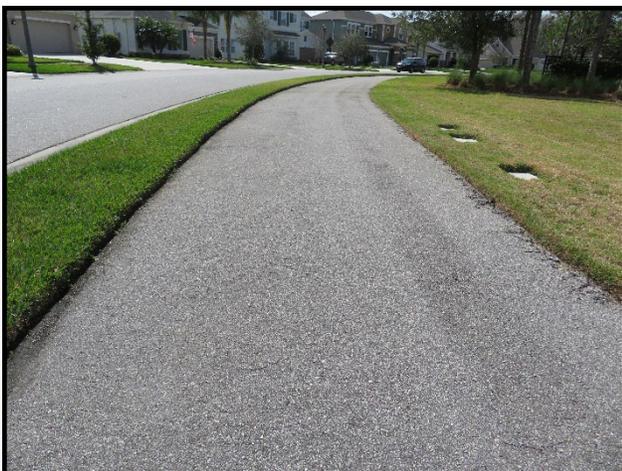
The District maintains approximately 1,950 square yards of asphalt pavement walking paths along Long Bow Way, Verona Lane, and adjacent to the playground. The paths are original and in good overall condition with previous repairs and minor deterioration evident. Unlike vehicular pavement, pedestrian walking paths are typically constructed with one pavement course due to a lighter traffic load. Therefore, a mill and overlay is not possible. We anticipate a useful life of 15- to 20-years and recommend the District budget for total replacement of the walking paths by 2033 and again by 2051.

Asphalt pavement walking path at Long Bow Way

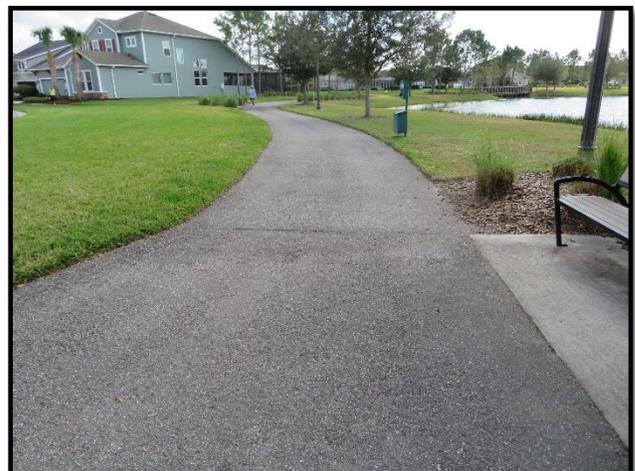
Asphalt walking path adjacent to playground

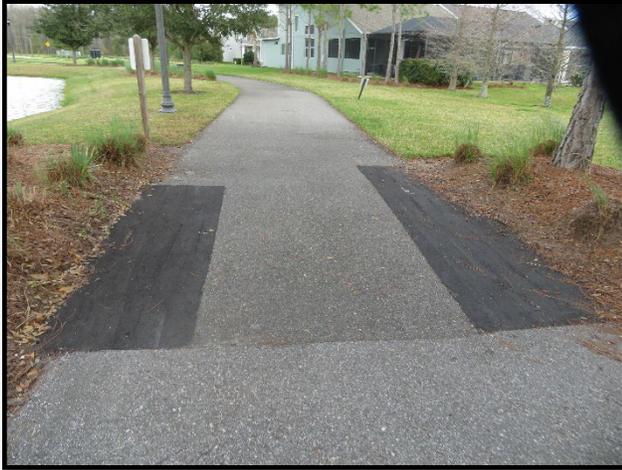
Previous repairs adjacent to boardwalk

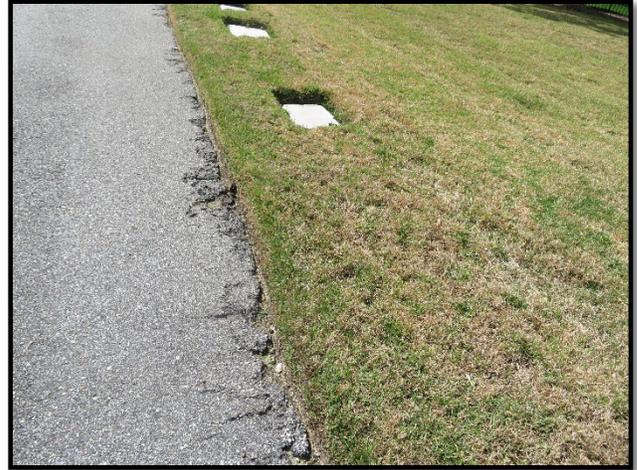
Asphalt pavement walking path edge deterioration

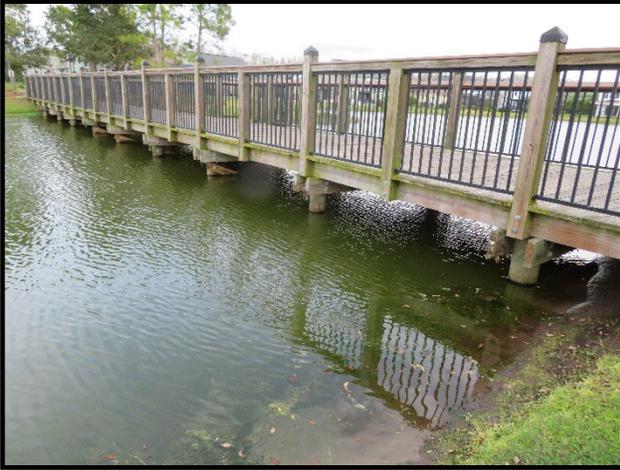
The District maintains three wood boardwalks throughout the community. The boardwalk over the lake between Renaissance Avenue and Caravan Avenue dates to 2016, the boardwalk behind the homes at Satilla Loop and Aviles Parkway dates to 2017 and the boardwalk through the natural preservation area between Aviles Parkway and Renaissance Avenue dates to 2021. The boardwalks are in good overall condition. We anticipate a useful life of 25- to 30-years and recommend the District budget for phased replacement beginning by 2043 and concluding by 2048. The District should fund repairs through the operating budget on an as needed basis to maximize the useful life of the boardwalks. Repairs may include inspection for warped or loose deck boards or railing components, replacement or additional installation of connections or fasteners, and partial replacements of structural members as needed.

Boardwalk over pond

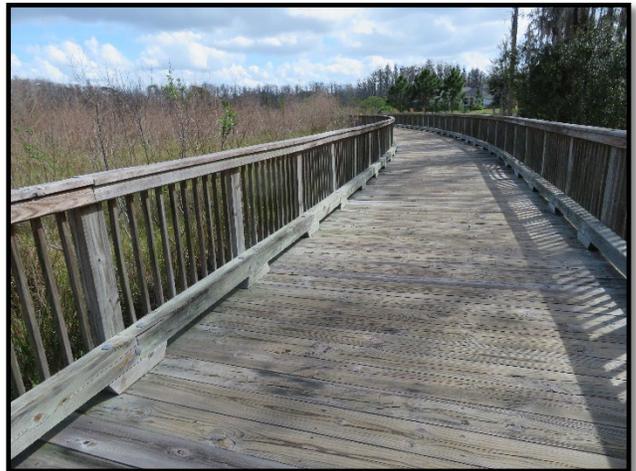
Boardwalk deck and railings

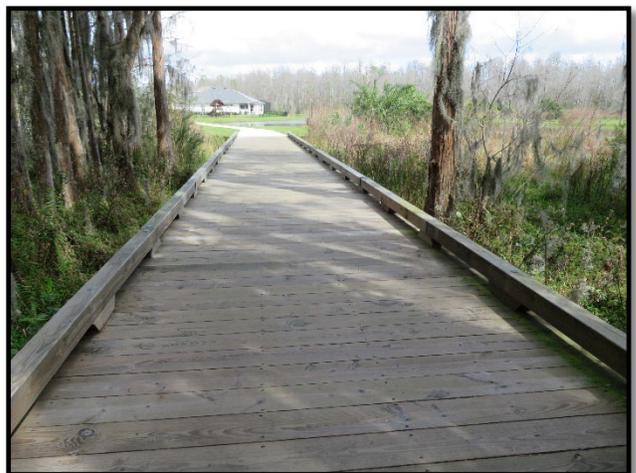
Boardwalk through natural preservation area

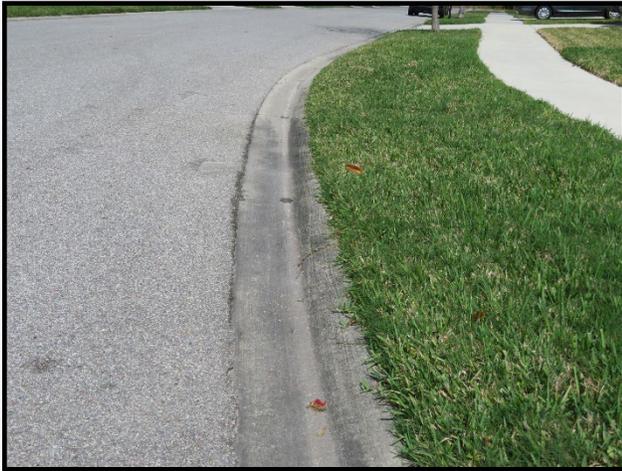
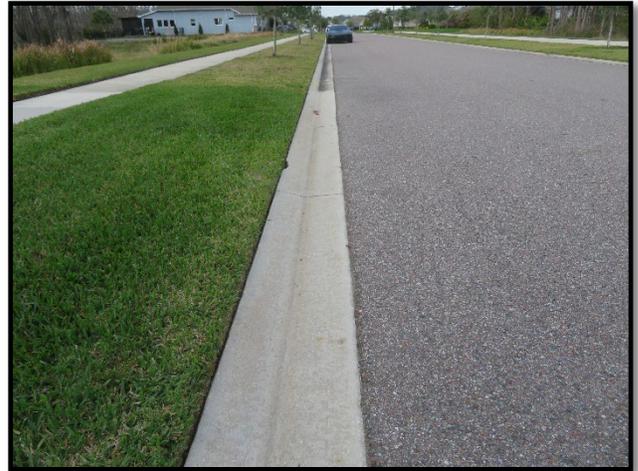
The District maintains approximately 78,900 linear feet of concrete curbs and gutters that line the asphalt pavement streets. The curbs and gutters are original and in good overall condition. Concrete has a long useful life of up to 65 years. Therefore, we do not anticipate the need for complete replacement of the concrete. We recommend the District budget for partial replacement of up to five percent (5.0%) of the concrete curbs and gutters in the next 30 years in conjunction with repaving.

Concrete gutter overview

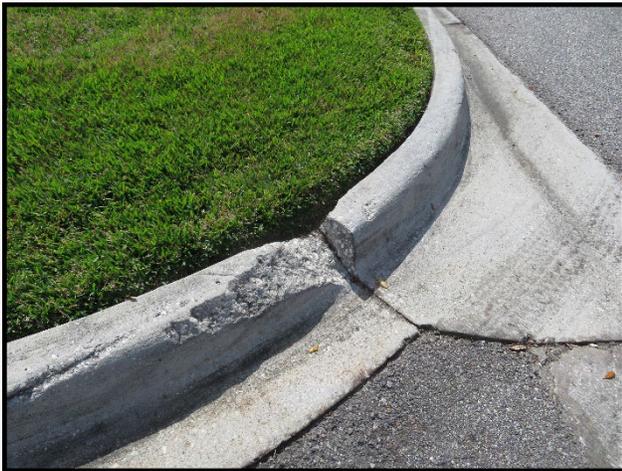
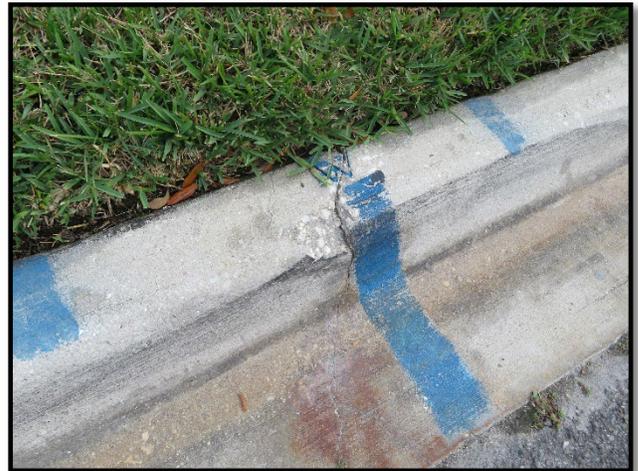
Isolated curb damage

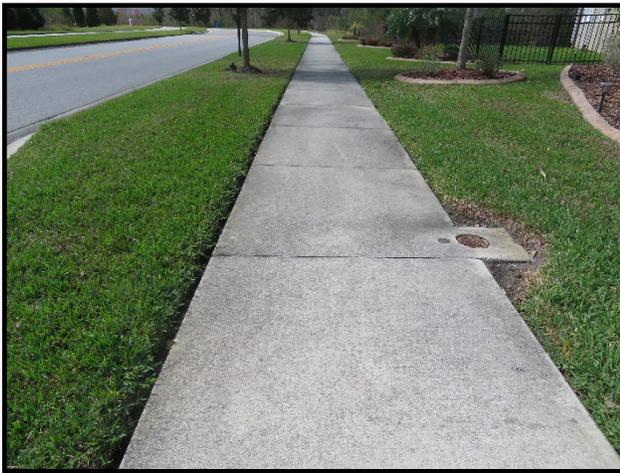
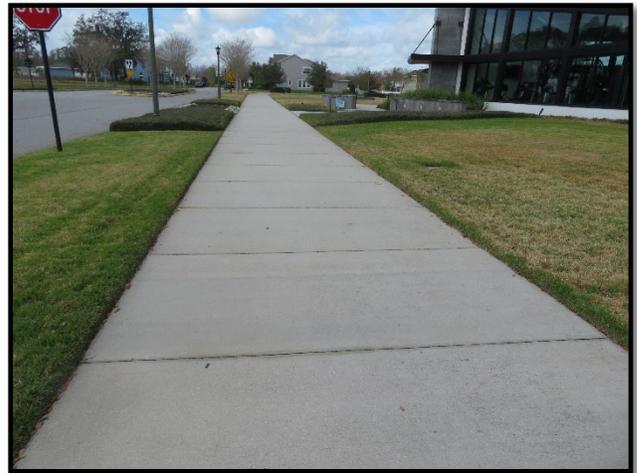
The District maintains approximately 327,500 square feet of concrete sidewalks located throughout the community. The concrete sidewalks are original and in good overall condition with isolated spalling evident. Concrete has a long useful life of up to 65 years. Therefore, we do not anticipate the need for complete replacement of the concrete. We recommend the District budget for partial replacement of up to eighteen percent (18%) of the concrete sidewalks in the next 30 years.

Concrete sidewalk

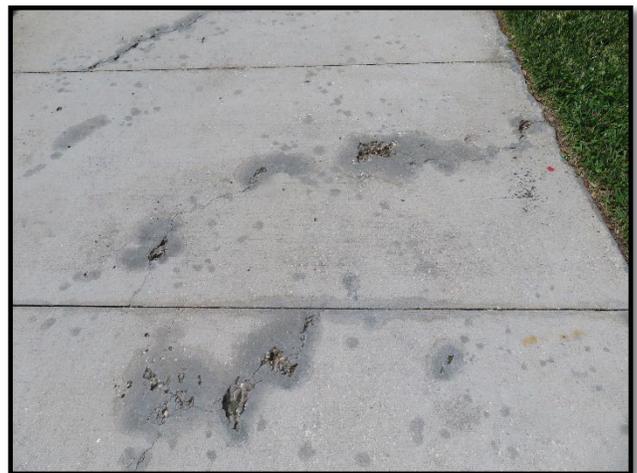
Isolated concrete spalling

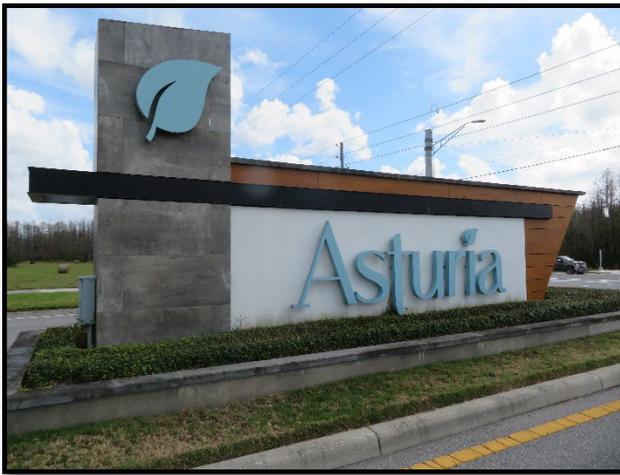
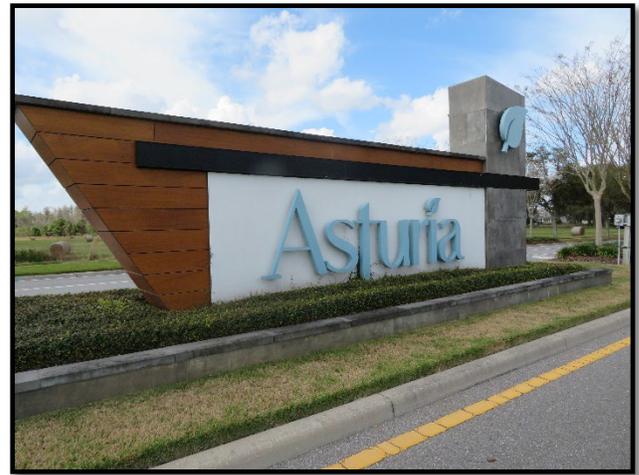
The District maintains the monument signage at the two community entrances. These components are original and in good overall condition. Entrance monuments contribute to the overall aesthetic appeal of the property. Renovations are based on the desire to update the perceived identity of the community. Therefore, the timing of renovations is discretionary. We recommend the District budget for renovation of the entrance monuments by 2036. Renovation should include replacement of the metal letters, tile and faux wood, and capital repairs to the structure. Interim repairs and paint finish applications should be funded through the operating budget as needed.

Entrance monument at Asturian Parkway

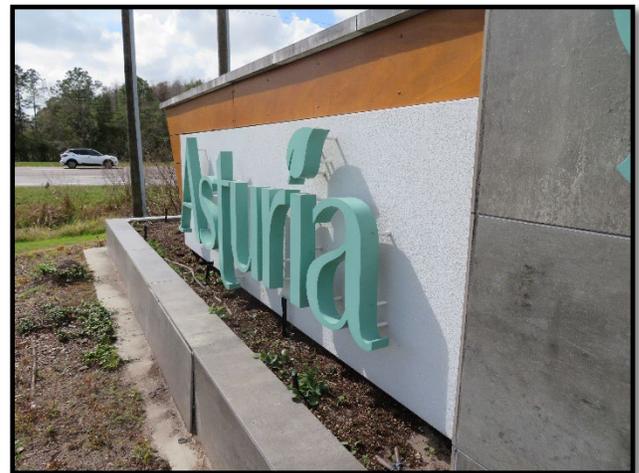
Metal letters at entrance monument

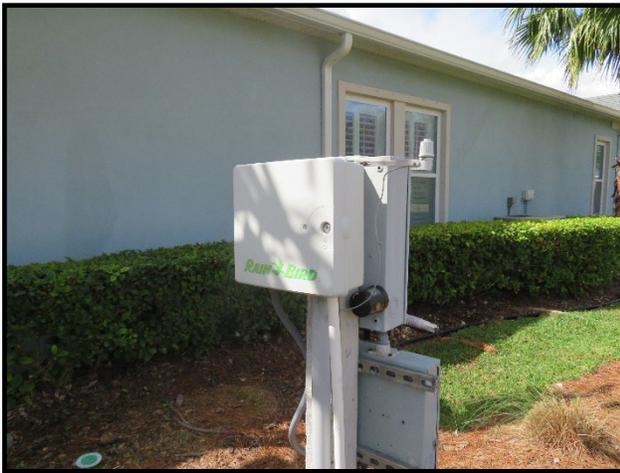
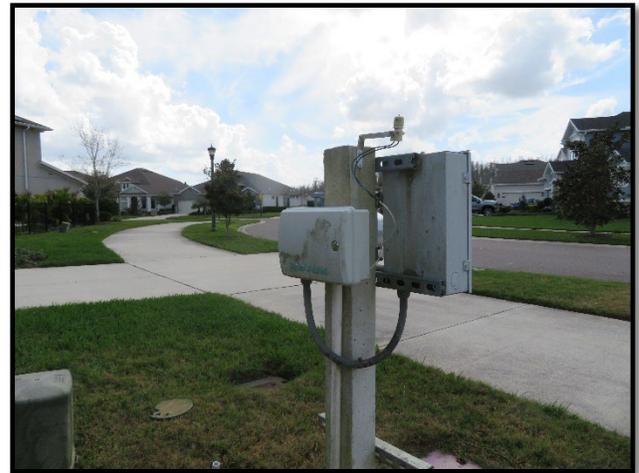
An irrigation system waters the common lawn and landscaped areas throughout the community. The system is original and reported in satisfactory operational condition. Over time, the effects of the elements will reduce the flexibility and durability of the underground pipe network. As such, we recommend the District budget for partial replacement of the system by 2042 and again by 2052. The District should fund interim head and controller replacements through the operating budget as needed.

Irrigation system controller

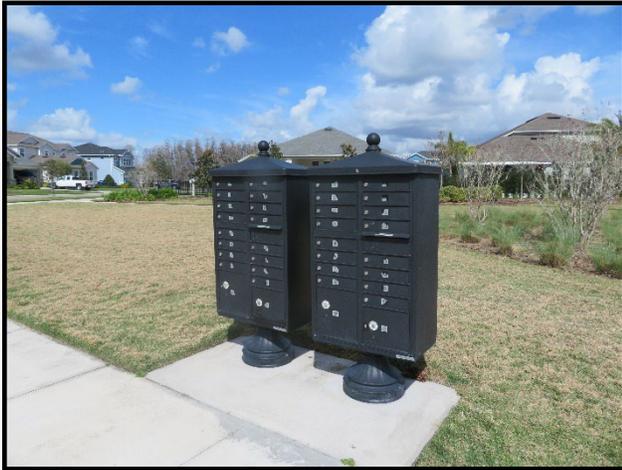
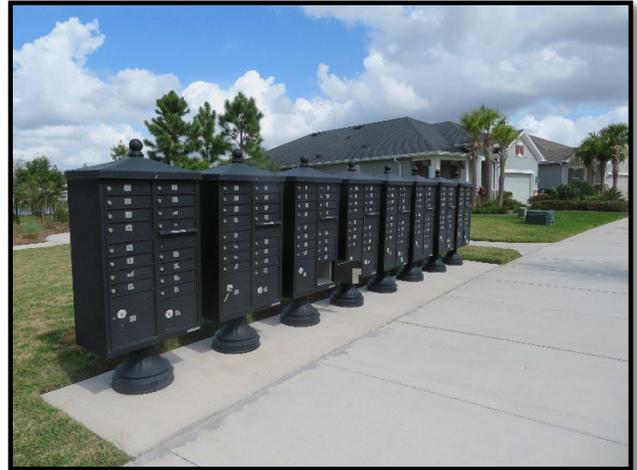
The District is responsible for 45 mailbox stations throughout the community. The mailbox stations are original and in good overall condition. We anticipate a useful life of 25- to 30-years and recommend the District budget for replacement by 2047. The District should fund interim paint finishes through the operating budget as needed.

Mailbox stations

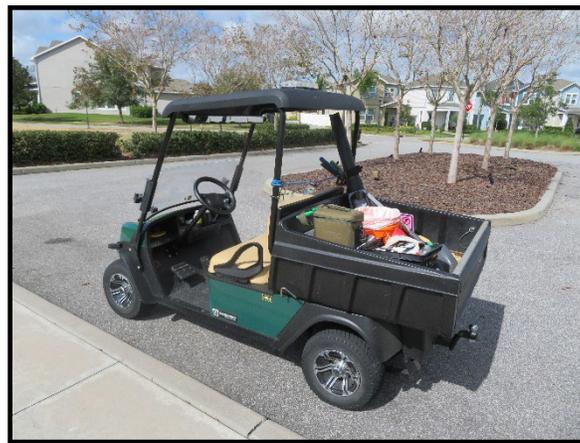
The District is responsible for the maintenance cart that serves the community. The maintenance cart is reported in satisfactory operational condition and dates to 2022. We anticipate a useful life of 5- to 10-years and recommend the District budget for replacement by 2029 and every seven years thereafter. The estimate of cost is based on a historical cost provided by Management.

Maintenance cart

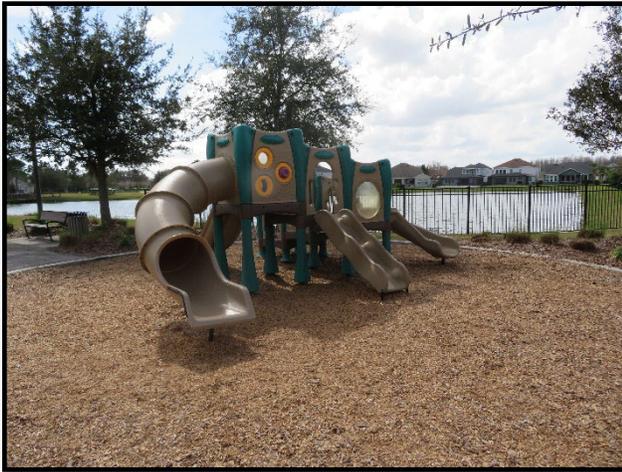
The District maintains the playground equipment at the intersection of Trails Edge Boulevard and Renaissance Avenue. The metal play structure, swing set and surrounding components date to 2016. The plastic play structure was installed in 2019. The playground equipment is in good overall condition. Playground equipment has a useful life of 20- to 25-years. We recommend the District budget for replacement by 2040.

Plastic play structure

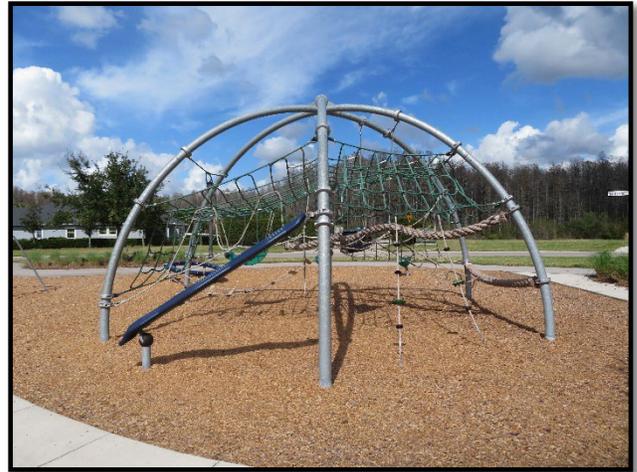
Metal play structure

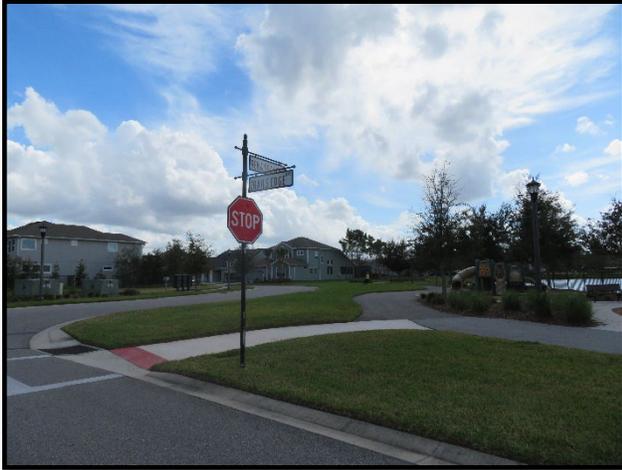
The District maintains the street identification and traffic management signage throughout the community. The signage is original and in good overall condition. We anticipate a useful life of 20- to 25-years, however the timing of replacement is discretionary based on aesthetic concerns rather than functionality. We recommend the District budget for replacement by 2040. Interim repairs and paint finish applications should be funded through the operating budget as needed.

Street identification signage

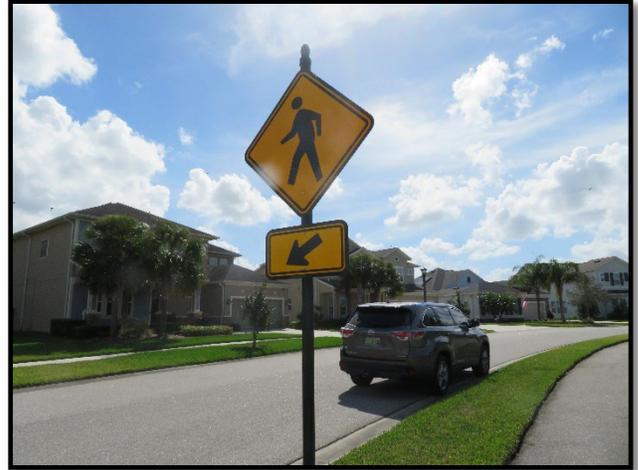
Traffic management signage

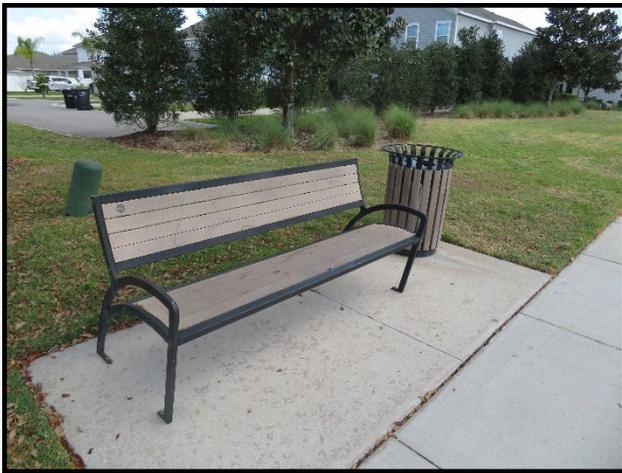
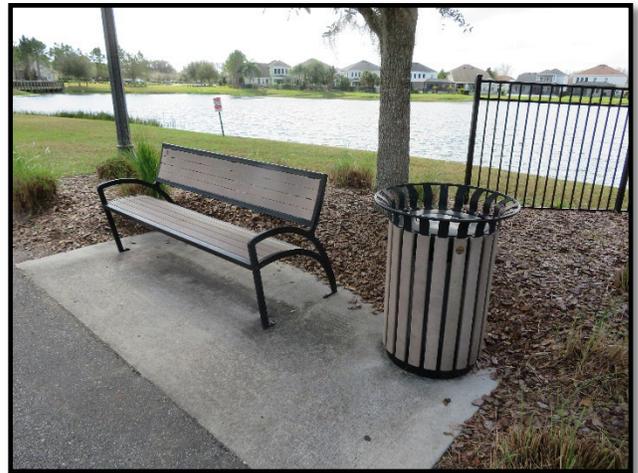
The District maintains the site furniture throughout the community. The site furniture is original and in good overall condition. We anticipate a useful life of 15- to 20-years and recommend the District budget for replacement by 2035 and again by 2053.

Bench and trash receptacle

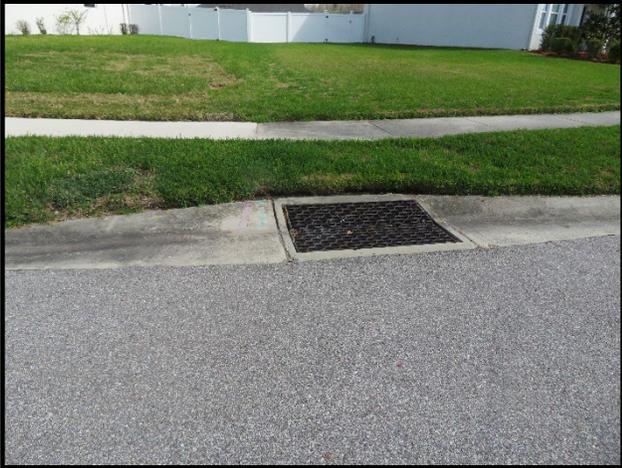
The District maintains the stormwater drainage system throughout the community. The system includes catch basins that collect stormwater from the pavement and drain into a connected series of pipes designed to carry the stormwater to the pond for processing. The District utilizes a wet pond system. Wet ponds treat storm water runoff by utilizing sunlight and vegetation which breaks down, filters and cleanses pollutants. The pond shorelines comprise approximately 20,000 linear feet. The ponds are original and in in good overall condition. Shoreline erosion can be caused by a variety of natural factors including steep slopes, changes in water elevation and storm water runoff. Several forms of shoreline stabilization methods exist, including but not limited to, installation of plantings, stone rip rap and bio-engineered synthetic stabilization systems. Erosion can lead to partial dredging of the pond and canal particularly near the drainage inlet and outlet structures. The District should map the shorelines and place marked stakes along the shorelines at multiple locations to monitor the effects of erosion.

Typical catch basin

The exact times and amount of capital repairs or replacements varies depending on natural forces. For budgetary purposes, we recommend the District budget for stormwater system maintenance, including catch basin repairs and pond shoreline erosion control, by 2031 and again by 2046. The District should consult with a pond specialist at the time of the project to determine the exact type of shoreline stabilization system to use.

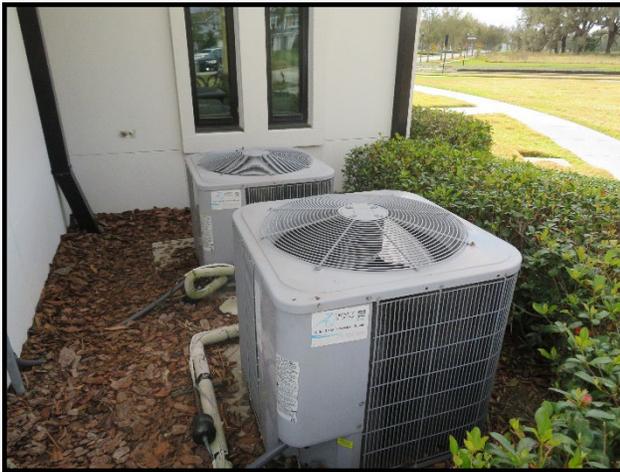
The District maintains four split system air conditioning units which serve the clubhouse and Fitness Center. A split system consists of an interior air handling unit and an exterior condensing unit. The split systems are original and reported in satisfactory operational condition. Management informs us one condensing unit was replaced in 2021 due to damage caused by a vehicle. We anticipate a useful life of 10- to 15-years and recommend the District budget for replacement by 2029 and again by 2042.

Air condensing units at clubhouse

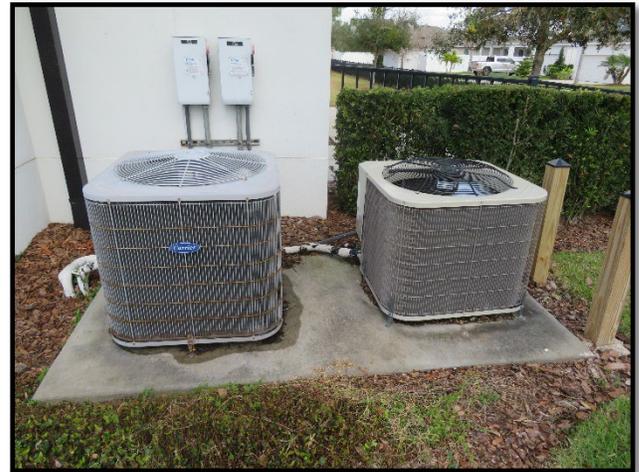
Air condensing units at Fitness Center

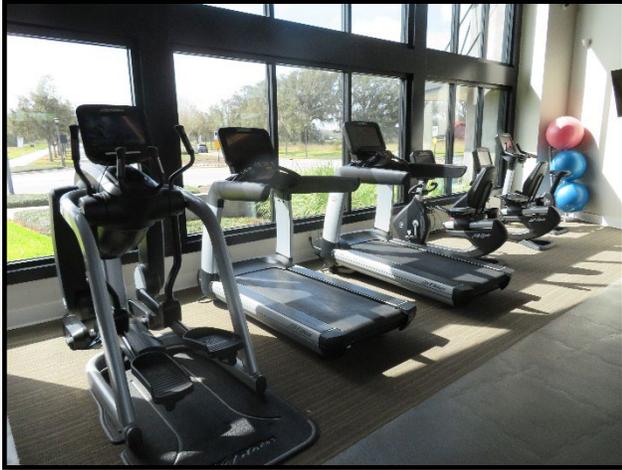
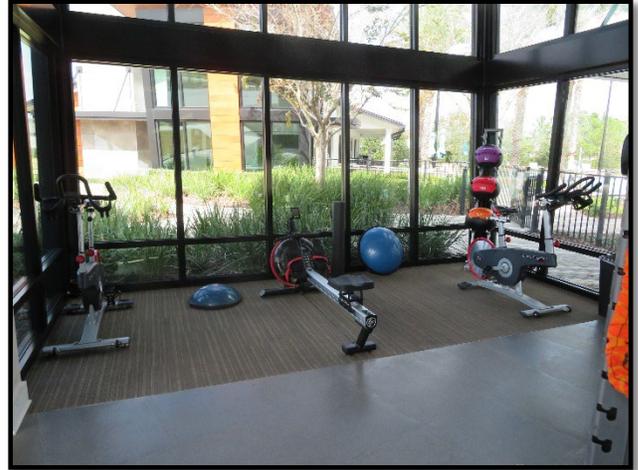
The District maintains various exercise equipment located at the Fitness Center, including treadmills, ellipticals, stationary cycles and various strength training equipment. The equipment is original and in good overall condition. The useful life of cardiovascular exercise equipment ranges from 5- to 10-years as a function of usage and regular maintenance. We recommend the District budget for replacement of the cardiovascular exercise equipment by 2025 and every seven years thereafter. The useful life of strength training exercise equipment ranges from 10- to 15-years as a function of usage and regular maintenance. We recommend the District budget for replacement of the strength training exercise equipment by 2030 and again by 2044. The District should fund interim maintenance through the operating budget on an as needed basis.

Cardiovascular exercise equipment

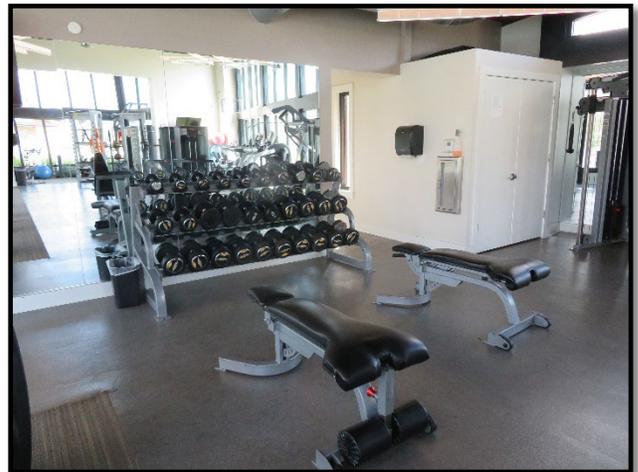
Strength training equipment

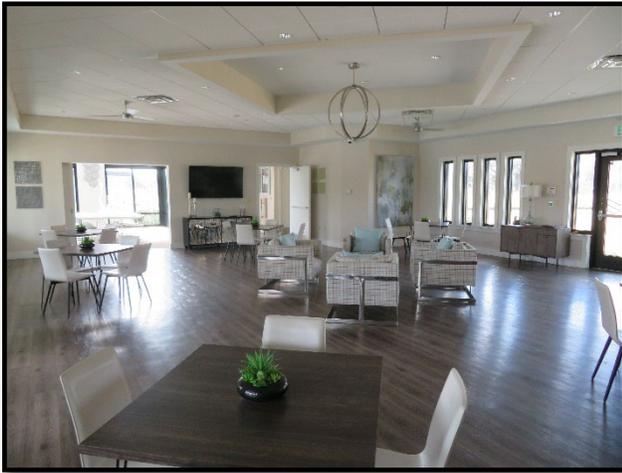
The clubhouse and Fitness Center interiors comprise vinyl plank, carpet and rubber floor coverings, paint finishes on the walls and ceilings, light and plumbing fixtures, cabinets and countertops, and various pieces of furniture. These components are original and in good overall condition. We recommend the District budget for a complete renovation of the clubhouse and Fitness Center every 20- to 25-years, with partial renovations every 10- to 15-years. We recommend the District budget for partial interior renovations by 2028. Our cost includes replacement of the carpet and rubber floor coverings, paint finish applications, and replacement of up to fifty percent (50%) of the appliances and furnishings. We recommend the District budget for a complete

Clubhouse interior overview

renovation of the clubhouse and Fitness Center by 2040. Our cost includes an allowance for replacement of all aforementioned components.

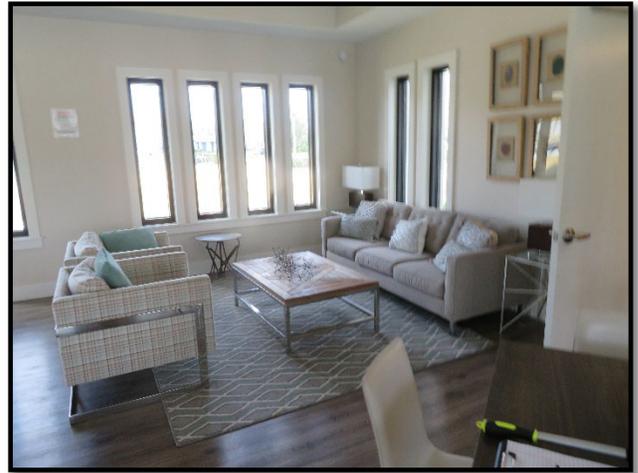
Clubhouse interior furnishings

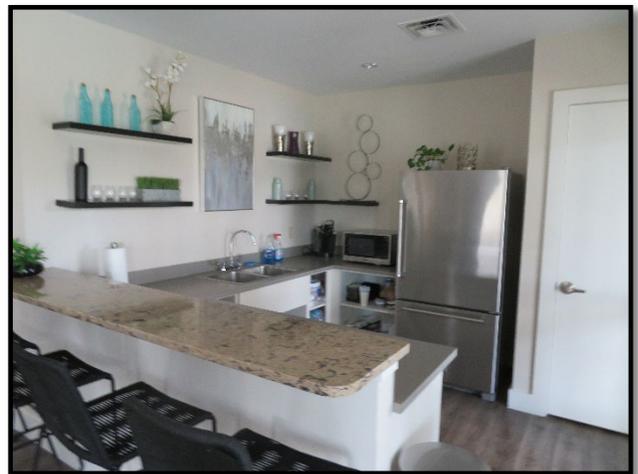
Clubhouse kitchenette

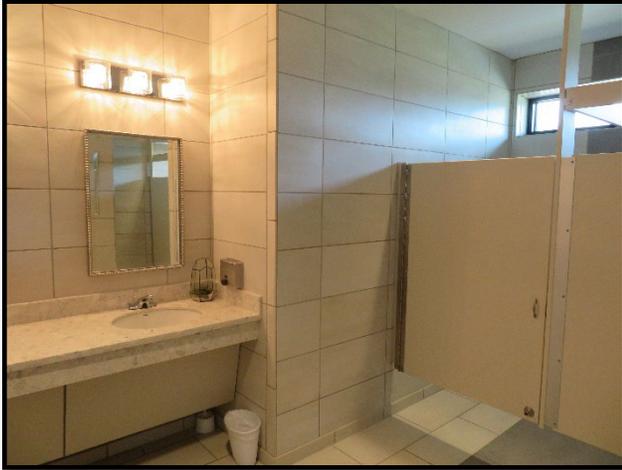
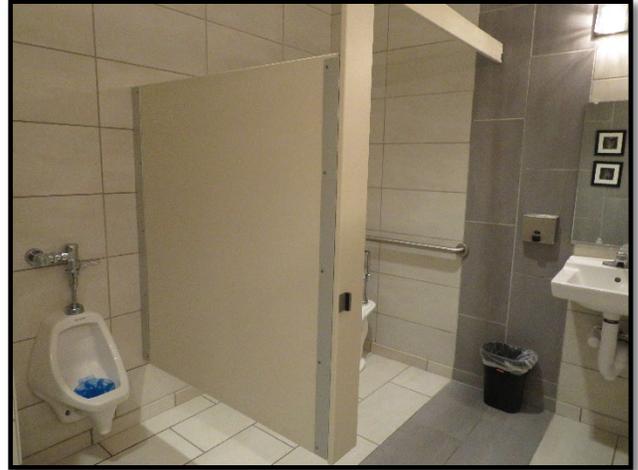
The District maintains four common area rest rooms located at the clubhouse and Fitness Center. The rest rooms comprise tile floor and wall coverings, paint finishes on the walls and ceilings, light and plumbing fixtures, and partitions. These components are original and in good overall condition. We anticipate a useful life of up to 25 years and recommend the District budget for rest room renovations by 2040.

Clubhouse rest room

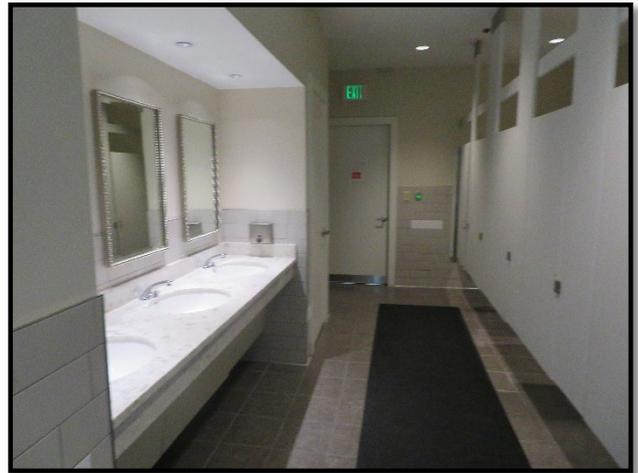
Fitness Center rest room

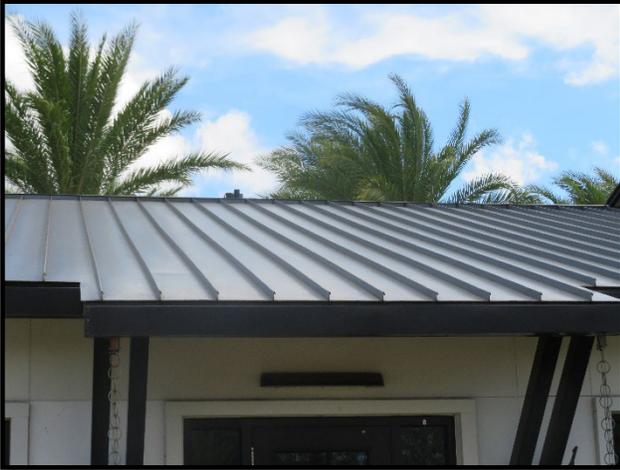
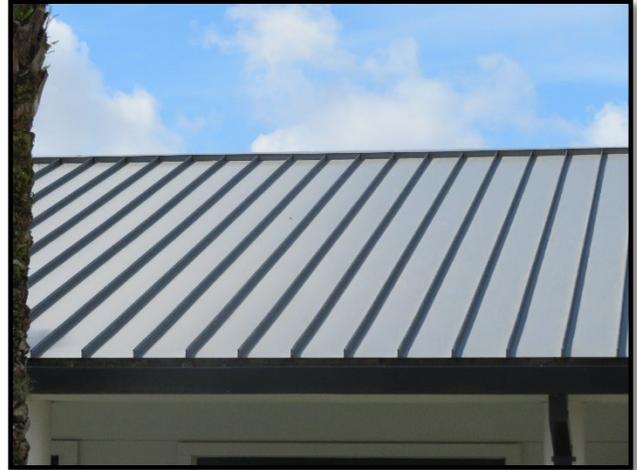
The District is responsible for approximately 75 squares of standing seam metal roofs located at the clubhouse and Fitness Center. Roof panels are crimped together rather than fastened by screws. The metal roofs are original and in good overall condition. Metal roofs of this type have a useful life of 30- to 35-years. The District should budget for replacement of the metal roofs by 2048.

Clubhouse metal roof

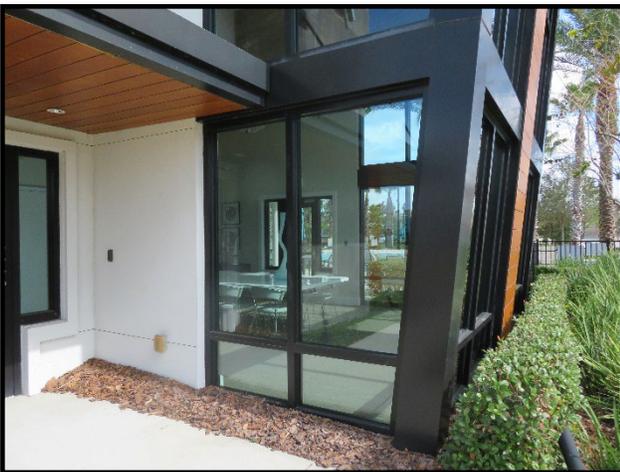
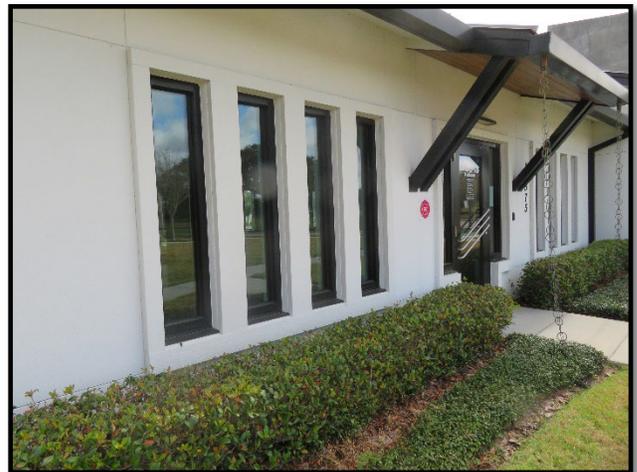
The clubhouse and Fitness Center utilize approximately 2,000 square feet of windows and doors. The windows and doors are original and in good overall condition. Windows and doors of this type have a long useful life of 35- to 40-years. The need to replace windows can be due to various reasons such as consistency in style and condition. We recommend the District budget for replacement of the windows and doors by 2053. Interim replacement of individual windows and/or doors is likely and should be funded through the operating budget on an as needed basis.

Clubhouse windows

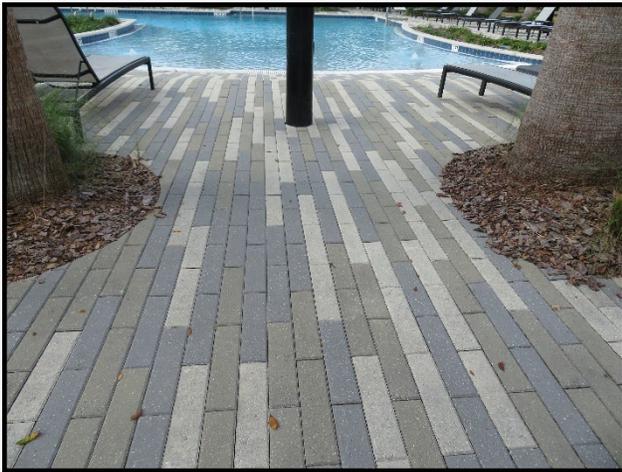
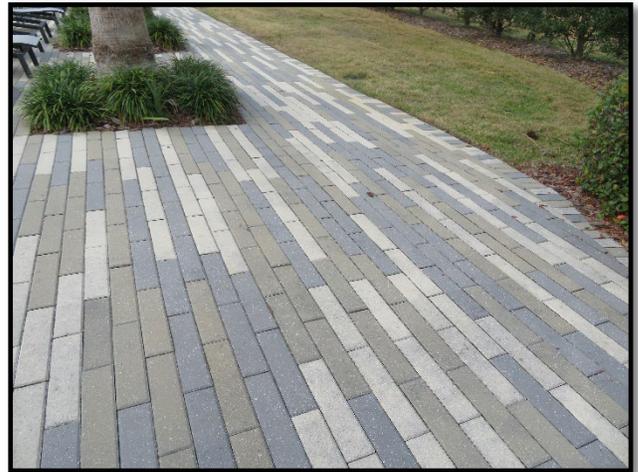
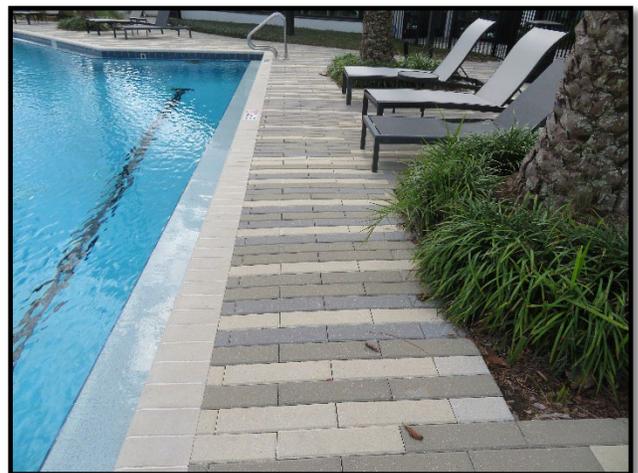
The District maintains the masonry pavers located at the pool deck. The pool deck is original and in good overall condition. Pavers are subject to settlement as a function of pedestrian traffic and discoloration or erosion as a function of the elements and pool water. We anticipate a useful life of up to 30 years and recommend the District budget for replacement of the pavers by 2046. The District should fund interim resetting and partial replacements through the operating budget on an as needed basis.

Masonry paver pool deck

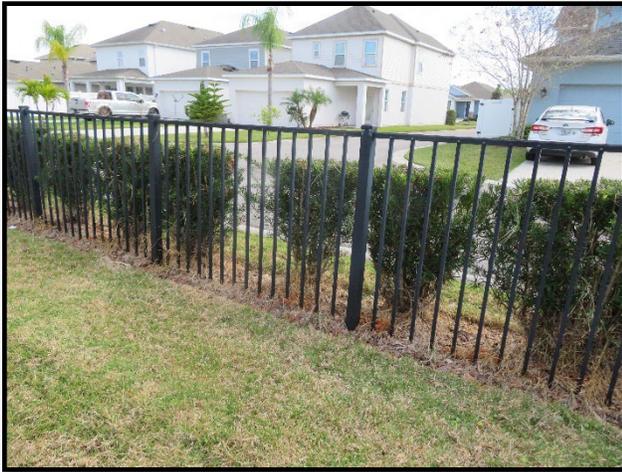
The District maintains approximately 1,125 linear feet of aluminum fence surrounding the pool area. This quantity includes the fence at the dog park and adjacent to the playground. The fence is original and in good overall condition. We anticipate a useful life of up to 25 years and recommend the District budget for replacement by 2041. Fence repairs including replacement of fasteners and connections should be funded through the operating budget on an as needed basis.

Aluminum pool fence

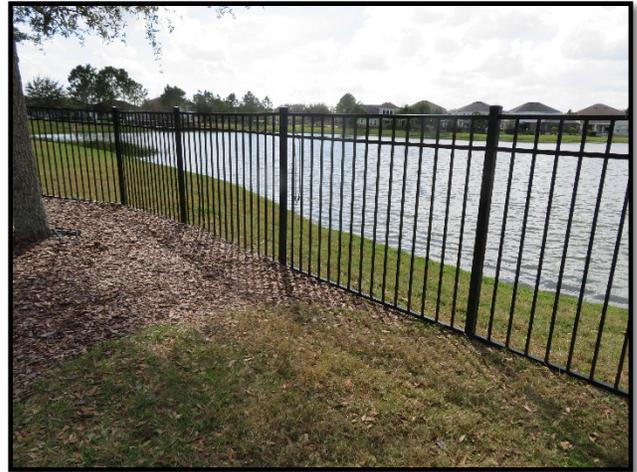
Aluminum fence adjacent to playground

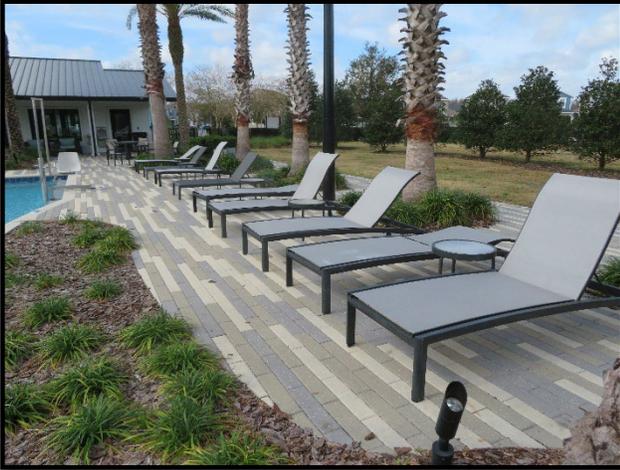
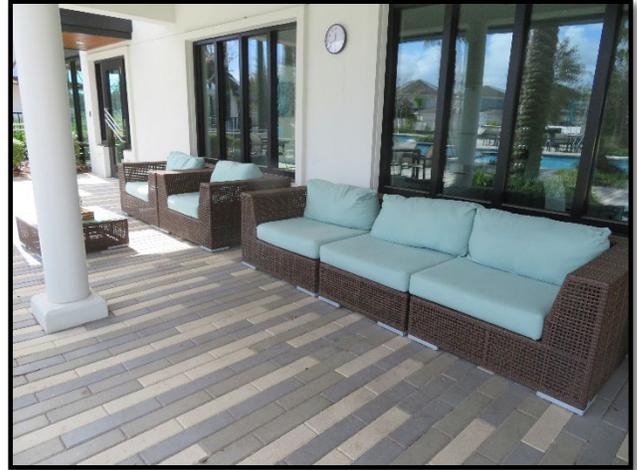
The furniture surrounding the pool includes chairs, lounge chairs, tables, umbrellas and trash receptacles. The furniture is original and in good overall condition. Management informs us the District re-straps the furniture on an as-needed basis. We anticipate a useful life of up to 10 years and recommend the District budget for phased replacement of up to fifty percent (50%) of the furniture by 2026 and every four years thereafter.

Pool furniture

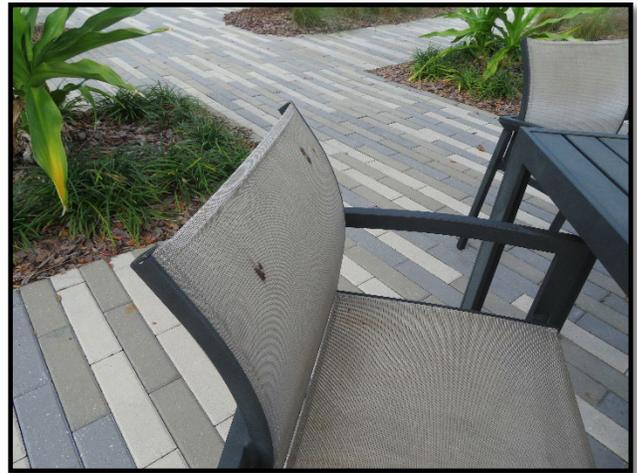
Stain at pool furniture fabric

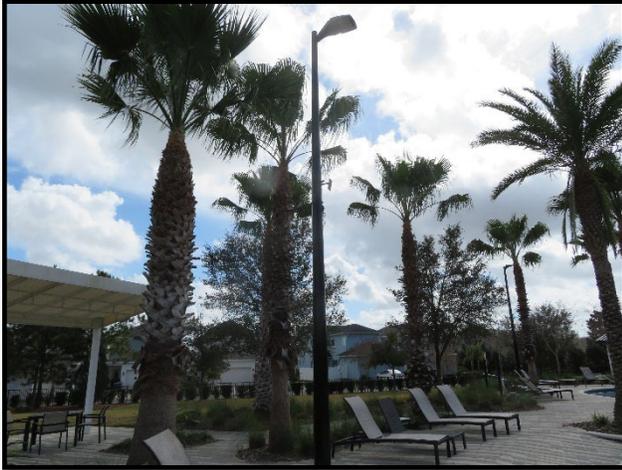
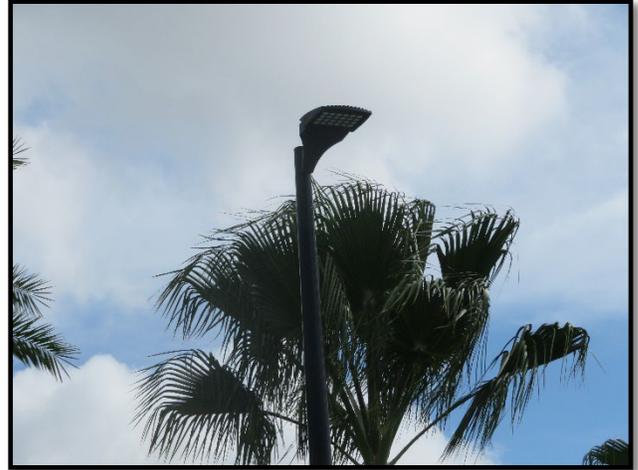
The District maintains eight decorative light poles and fixtures at the pool area. The light poles and fixtures located along the streets throughout the community are maintained by the Utility Company. These components are original and in good overall condition. We anticipate a useful life of 25- to 30-years and recommend the District budget for replacement of the light poles and fixtures by 2046. Our cost includes an allowance for replacement of the pole, base, fixture, and minor electrical repairs at the time of replacement. Interim replacement of light bulbs and/or fixtures should be funded through the operating budget on an as needed basis.

Light pole and fixture at pool

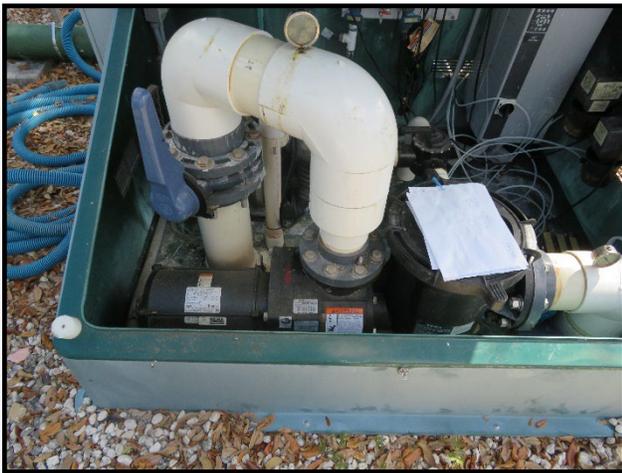
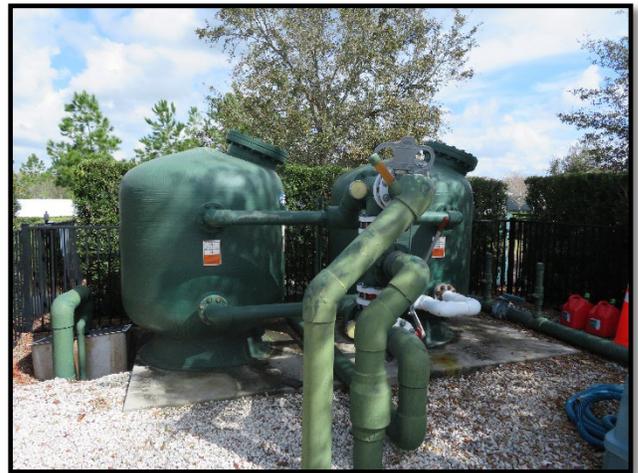
The pool is served by various pipes, valves, electrical systems, pumps, filters, and chlorinators. The equipment is primarily original and reported in satisfactory operational condition. Simultaneous failure of the equipment is unlikely. We instead include an allowance to fund replacement of up to thirty-three percent (33%) of the pool equipment by 2026 and every five years thereafter.

Pool mechanical equipment

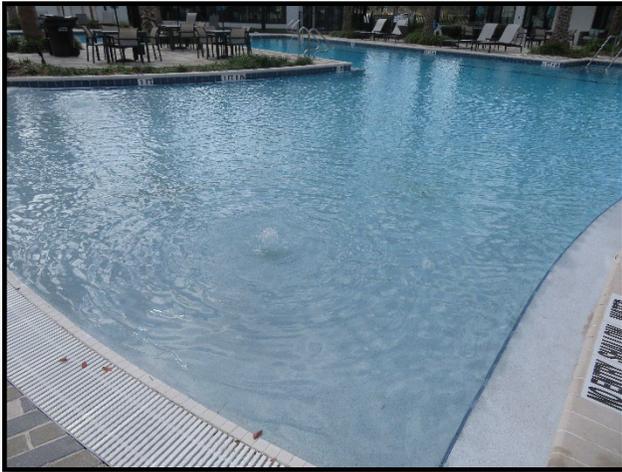
The finish at the pool wall and floor surfaces is original and in good overall condition. We anticipate a useful life of 8- to 12-years and recommend the District budget for resurfacing of the wall and floor areas, as well as replacement of the pool tile, and replacement of the pool coping, as needed, by 2028 and every 12 years thereafter. Our cost includes an allowance for minor repairs to the underlying pool structure at the time of pool finish replacement.

Pool plaster finish
