ASTURIA COMMUNITY DEVELOPMENT DISTRICT FULL RESERVE STUDY REPORT

For 30-Year Projection Period: FY 2023 through FY 2053

Odessa, FL

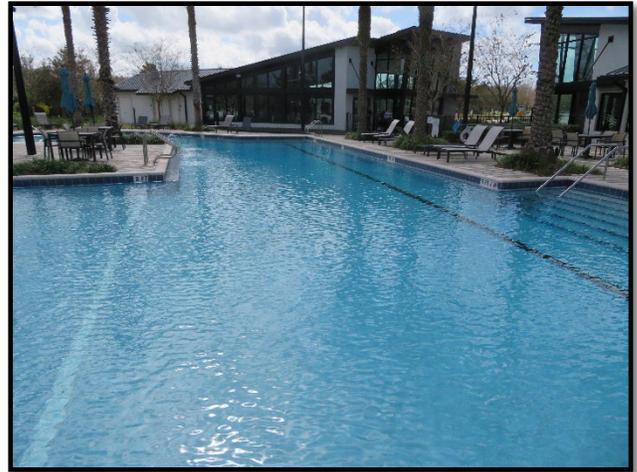
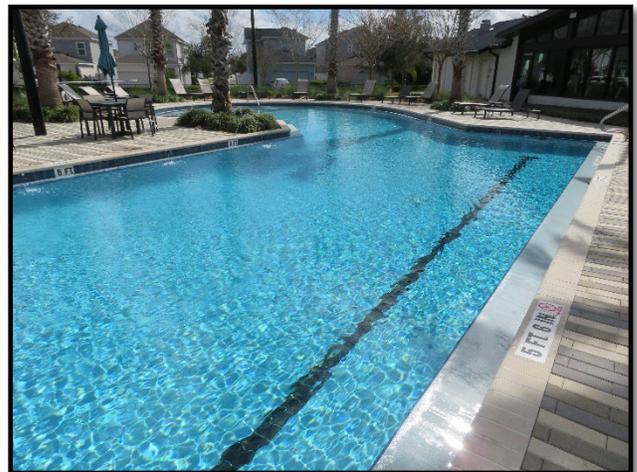
Pool overview
