ASTURIA COMMUNITY DEVELOPMENT DISTRICT FULL RESERVE STUDY REPORT

For 30-Year Projection Period: FY 2023 through FY 2053

Odessa, FL

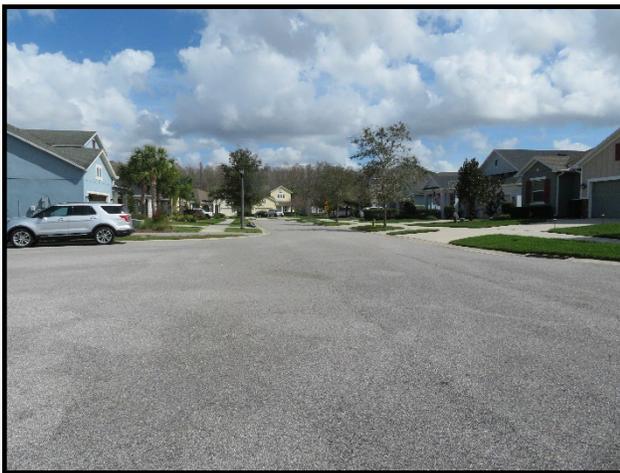
Asphalt pavement at Verona Lane

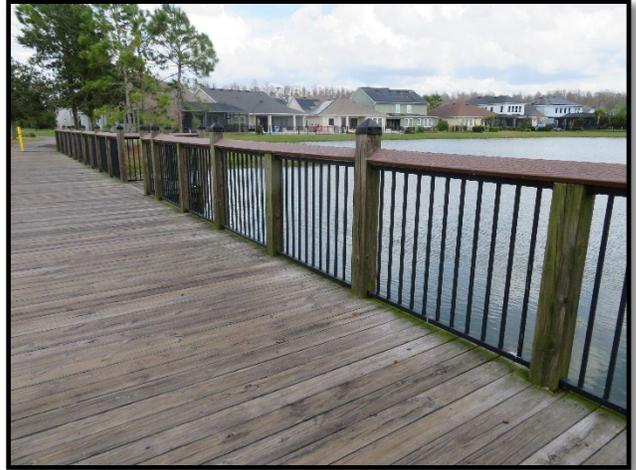
Boardwalk deck and railings

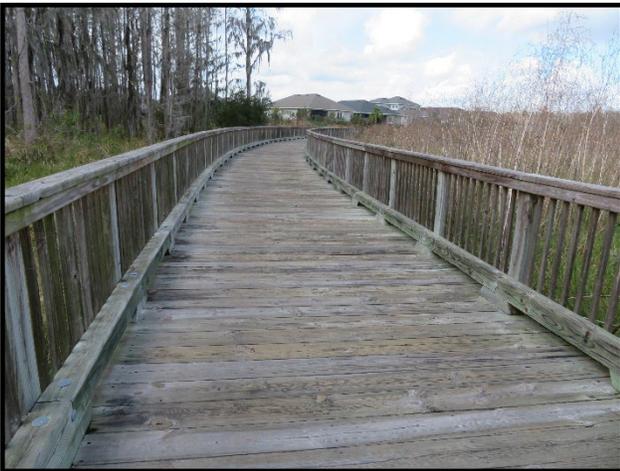
Boardwalk behind homes at Satilla Loop and Aviles Parkway

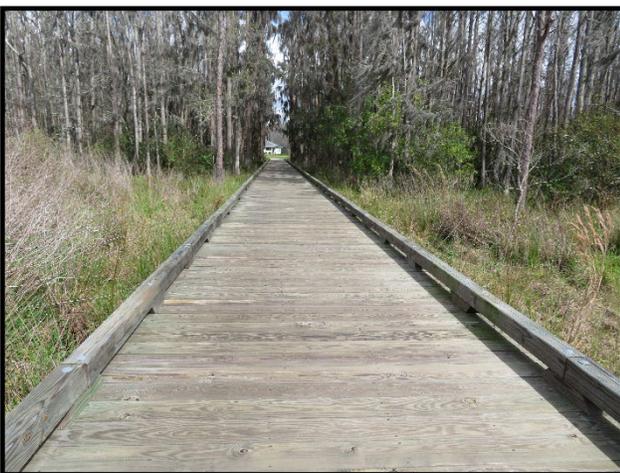
Boardwalk through natural preservation area

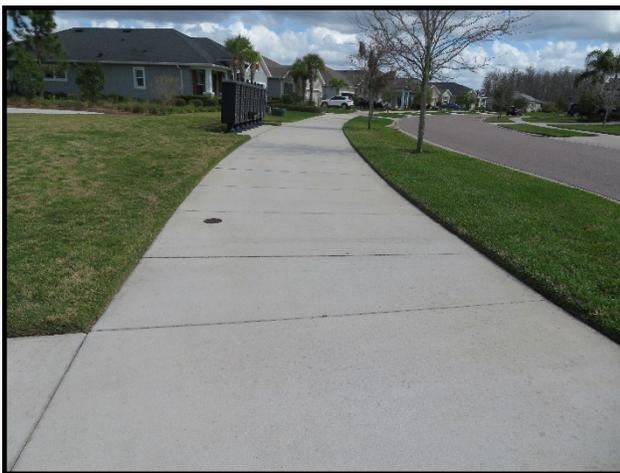
Concrete sidewalk

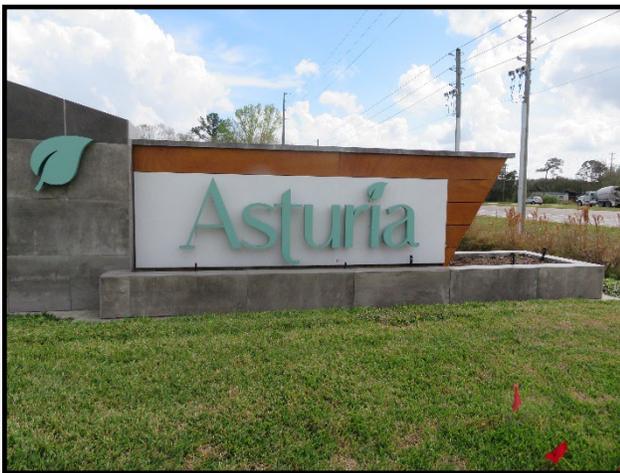
Entrance monument at Promenade Parkway

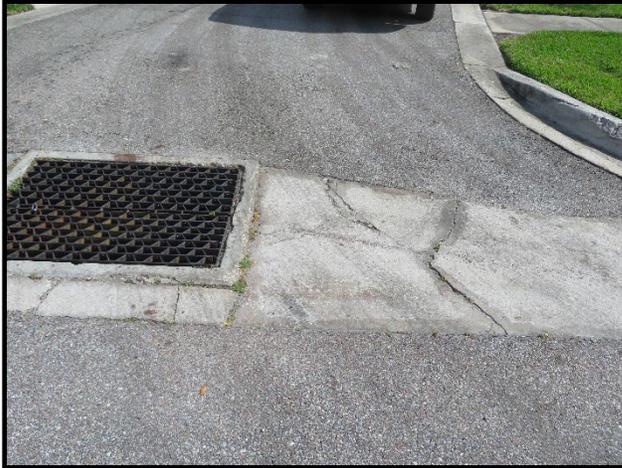
Minor settlement adjacent to catch basin

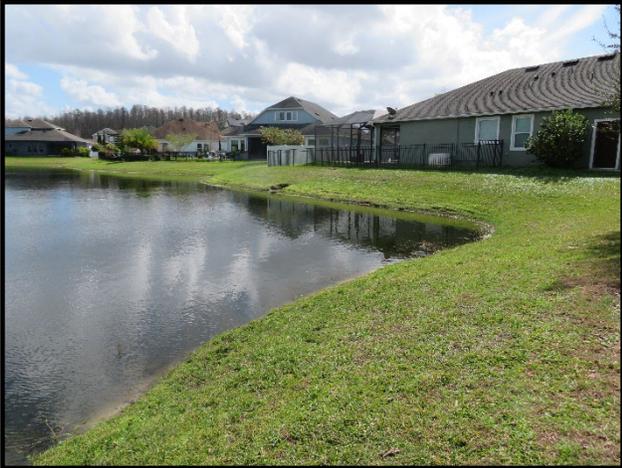
Pond shoreline

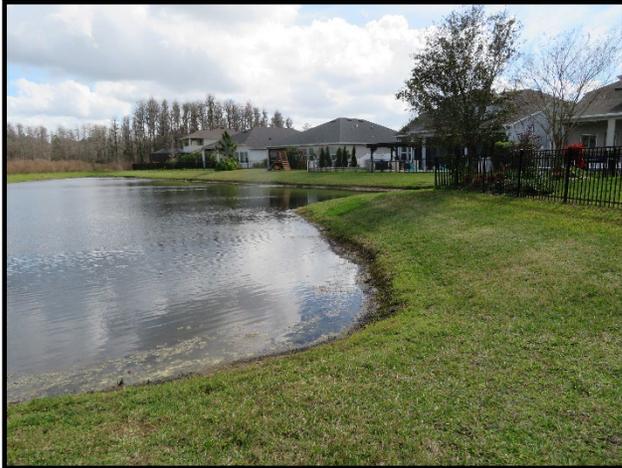
Pond shoreline

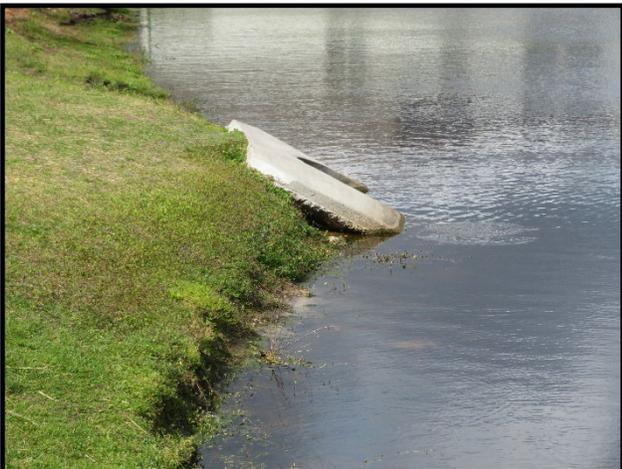
Minor settlement behind pond inlet structure

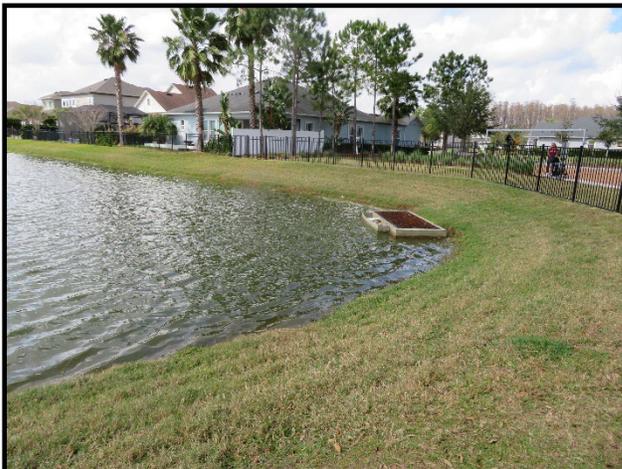
Pond shoreline and outlet structure

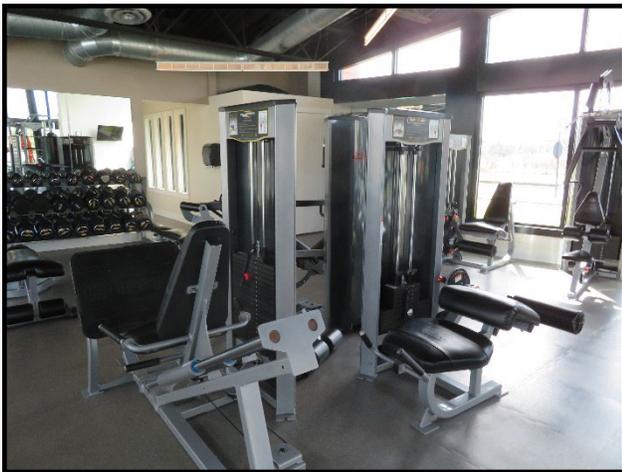
Strength training machines

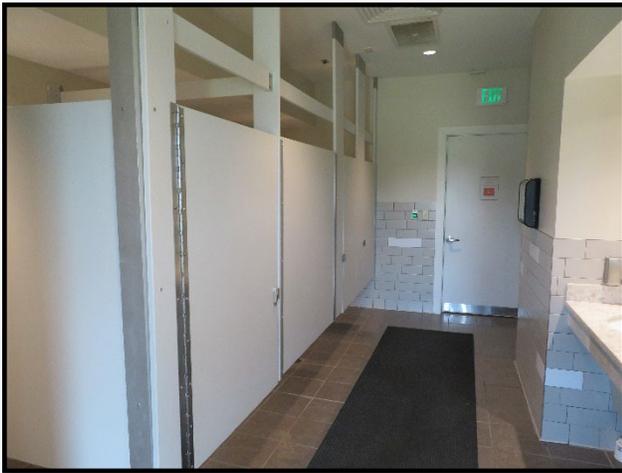
Fitness Center rest room

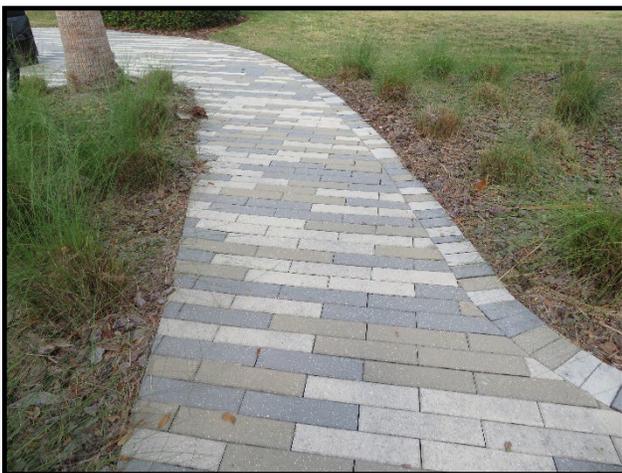
Masonry paver pool deck

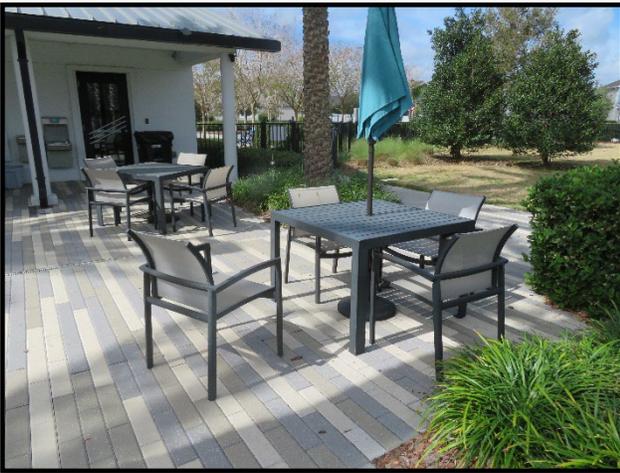
Pool furniture
